The New Zealand LIFT FAX

05/2008

OTIS Gen2 ACCIDENT – August 2009

A lift Consultants review.

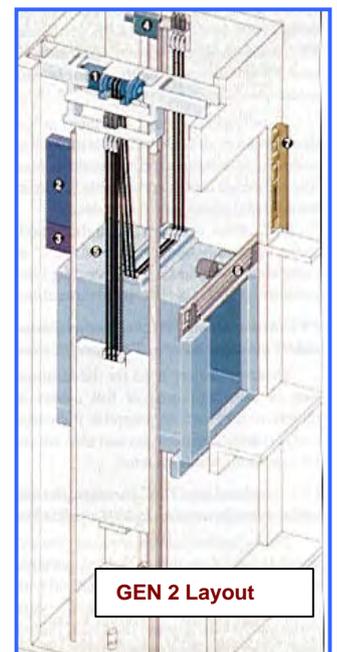
- o All traction lifts have brakes to hold a lift when stationary, and all are electro-mechanical set by spring tension to fail safe, and are released through the energizing of an electrical magnetic coil that releases the motor so that it can freely turn. What differs in the Gen2 brake design is that it has no means of mechanically releasing the brake, and so relies totally on electrical operation, whereas historically all brake mechanisms had mechanical means of releasing the brake to be able to test the brake, overspeed the machine, and move the lift without power. And so although Otis suggests that Dave went outside procedure, of which in this instance there is none, the design by not incorporating a means of mechanical release for the above purposes, meant Dave, if he was to solve the problem, needed to determine his own method.

- o Evidence was indicated that a claw hammer was found lodged in the motor pulley / belt drive without further comment, but when forced to use what was available to secure the equipment, it is likely Dave considered these things:-

- a. Understanding the lift would run up if the brake released, blocking the counterweight as detailed would stop this movement, but also wedging the belt drive mechanism to restrict movement

once the brake released could also control the lift. This may have been reasoned by Dave, and explains the location of where the hammer was found, and possibly why he was entrapped if it unexpectedly failed before he could remove the brake supply.

b. Surface rust on the brake disc seems the most likely reason for the brake not lifting after sitting for an extended time in a damp environment, and although the coil would be designed to lift the brake against the spring load, it is at its weakest point of attraction at its maximum airgap, and although designed to lift against the spring, it seems after 2 months the force at this point was insufficient to break surface corrosion . . . without assistance such as being separated with the point of an interposed screwdriver. Once released and the disc turned and the lift was stopped and started a few times, it would probably be all that was needed to be able to use the lift until the disc could be inspected, stripped and cleaned at a later date.

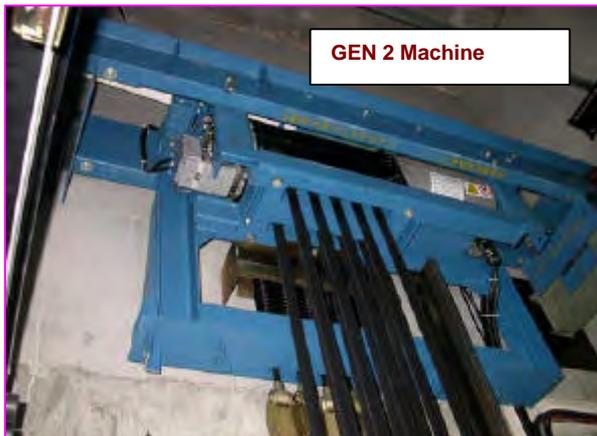
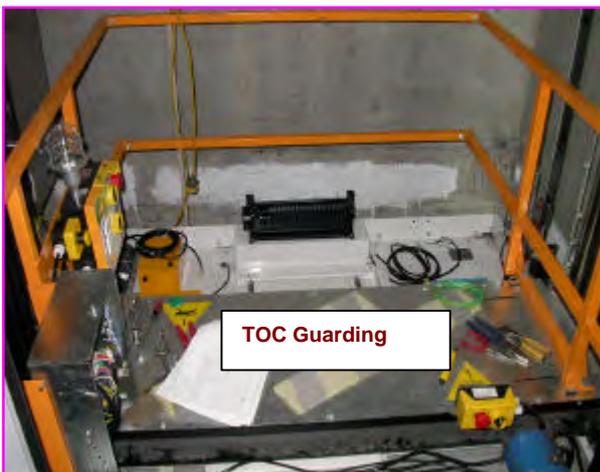
- 12.3 That due to the brakes design, the magnetic force necessary to release it was insufficient when unforeseen minor rusting of the elements occurred, and because no allowance was made for mechanically releasing the brake for known industry testing functions, Dave Shaw in resolving the problem which was his job, solved it, but subsequently lost his life when the untested steps he had to take to safeguard himself as best he could by himself, most likely failed unexpectedly when not in his safe space.

- 13.1. That the brake materials that make up the operating surfaces be considered and where necessary changed to remove the likelihood of corrosion affecting the operating surfaces. (It is understood Otis is already investigating this.) Alternatively strengthen the designs magnetic lifting force to be able to break any sticking due to mild surface corrosion.

- 13.2. That Otis reconsider the advantages of runaway testing for brakes and governor over speed testing and reinstate a mechanical means of emergency brake release that can preferably be implemented outside the shaft, and possibly return to employing a hand-winding mechanism.
