The New Zealand LIFT FAX

05/2008

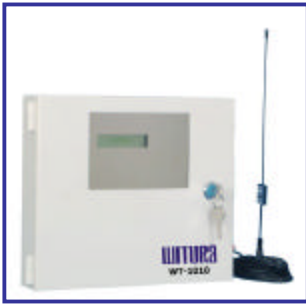
GSM Lift Emergency Voice & Monitoring System:

- o Supports dual or quad band GSM.
- o Can connect to existing lift phone.
- o LCD display to indicate calling no.
- o Programmable by PC or SMS.
- o SMS alert for lift power failure.
- o Remote control 2x30A output relays.
- o Two low voltage inputs for SMS alerts
- o One independent local alarm output
- o Six hour mains failure battery backup.
- o SMS signal strength test.
- o Configurable SMS alert content.
- o Up to 8 pre-programmable numbers.

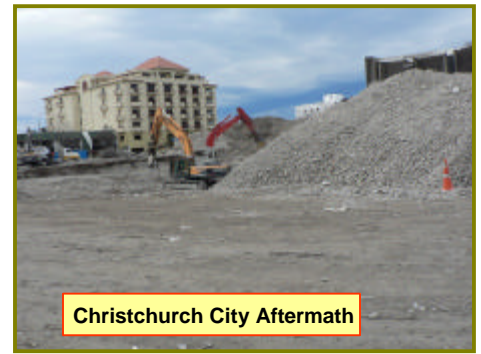
That said, the comprehensive Turkey report wasn't subjected to such tight control and many visits to damage sites made it possible to put together a much more relevant report.

The significance of the facts that emerged reflected the hearsay evidence that I had experienced in Christchurch and that is slightly reflected in my initial table of comparison based only on the first shake.
